LEAD-BASED PAINT COMBINATION
INSPECTION AND RISK ASSESSMENT REPORT
FOR LANDLORD OWNED PROPERTY

**HomeSource east Tennessee
109 Winona St.
Knoxville, TN 37917**

Date of Inspection: May 16-18, 2018

Date of Report: May 23, 2018

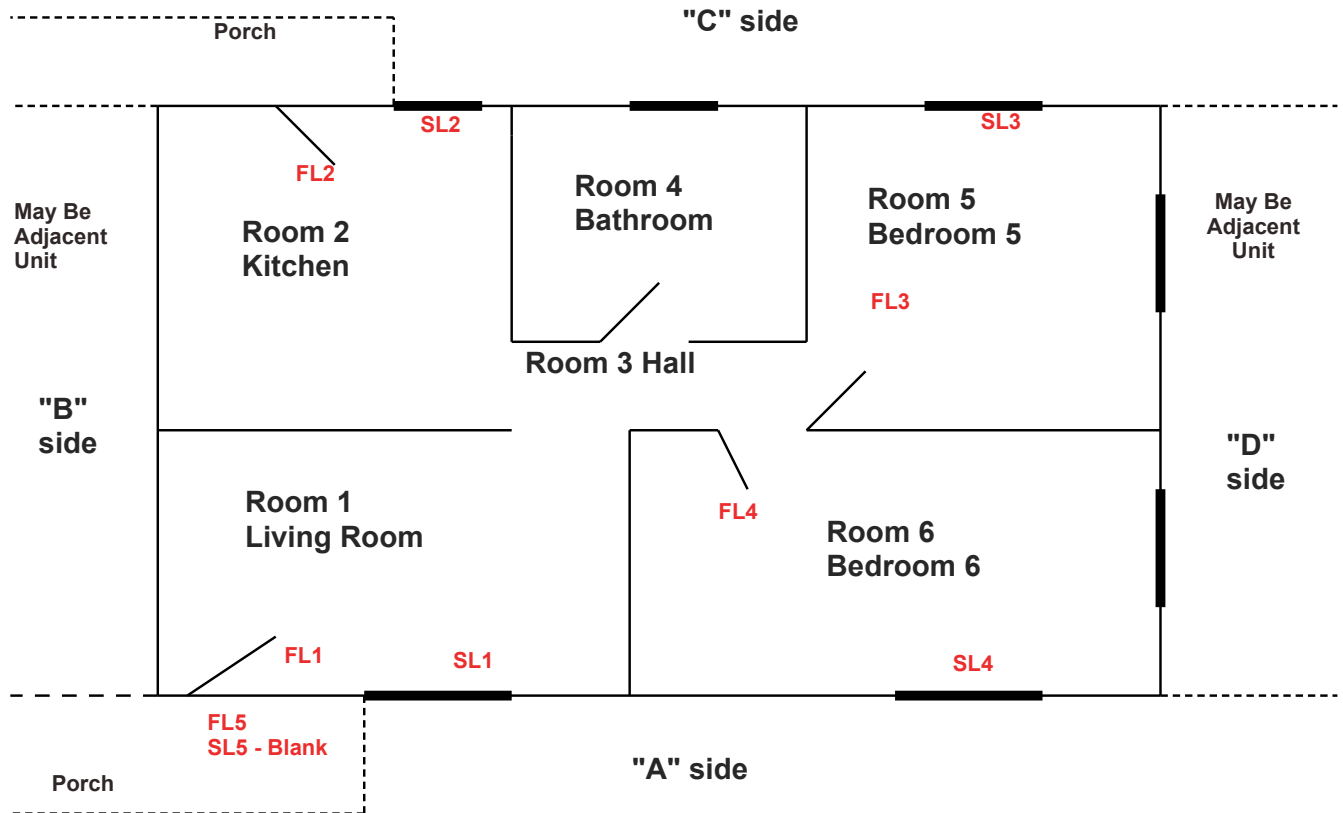
Typical Upper Unit
Some Units may be reversed

Drawings show locations of rooms and dust sampling locations

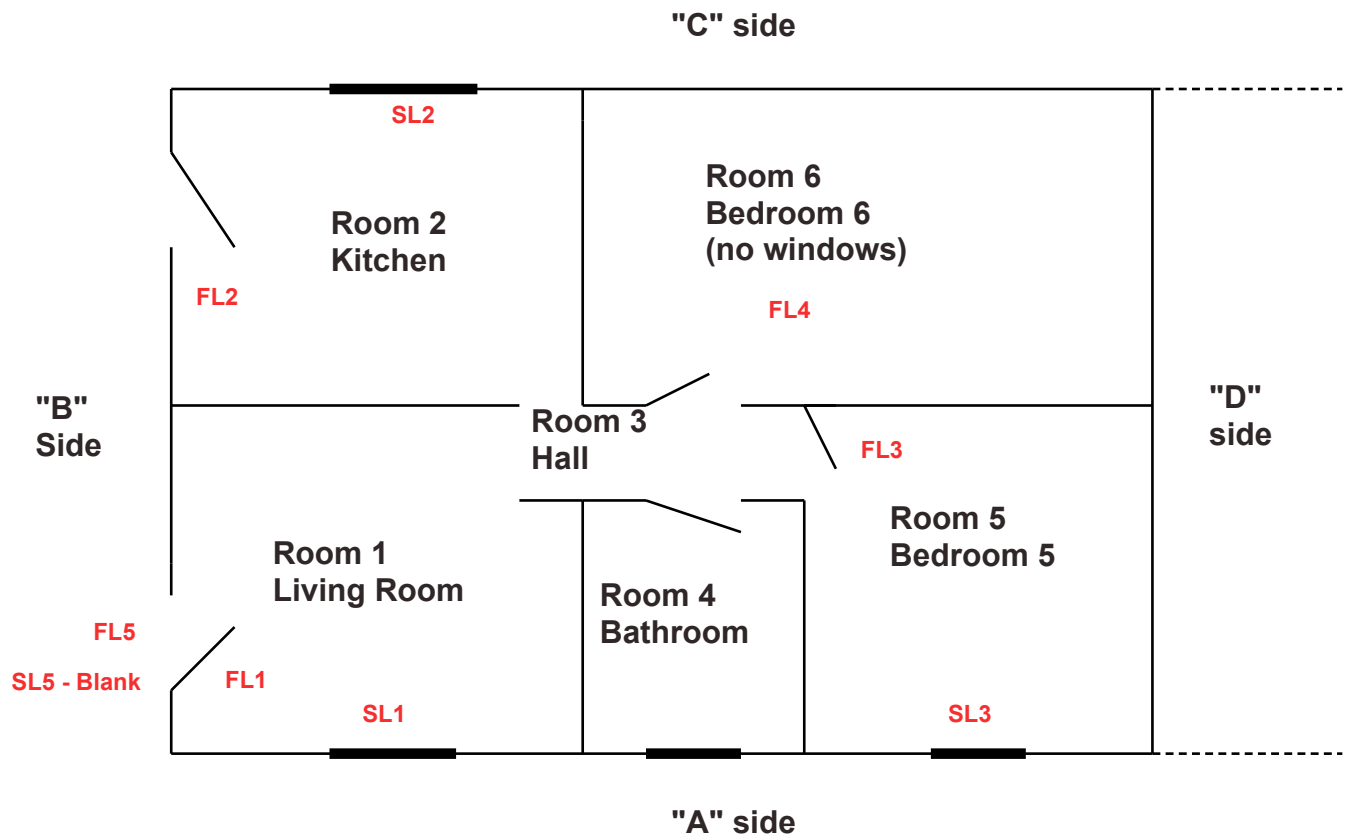
Typical Lower Unit
Some Units may be reversed

Drawings show locations of rooms and dust sampling locations

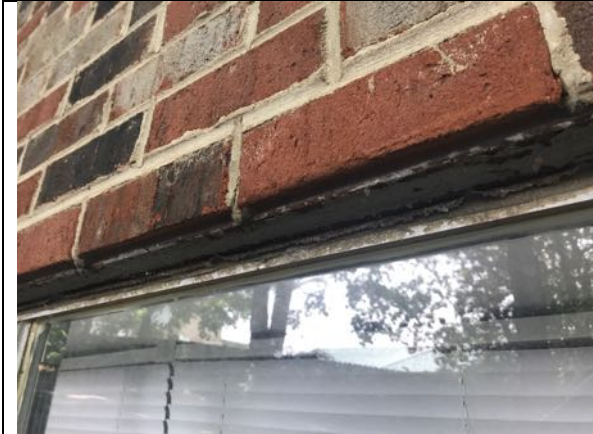
Photo 29 - Typical window/door lintle - POSITIVE

Options are shown for BOTH Interim Controls and Abatement unless noted otherwise		Chosen Option
Paint film stabilization for the components listed, includes wet scraping and repainting – Deteriorated paint must be wet scraped prior to repainting or encapsulation – – NOT SUITABLE FOR ABATEMENT	\$5-10/lf or ft ²	
Component enclosure with vinyl or metal siding	\$5-10/lf or ft ²	
Lead Paint removal and repainting with lead-free paint	\$5-10/lf or ft ²	
Encapsulation – Deteriorated paint must first be stabilized before encapsulation with a lead-paint Encapsulant as per manufacturer’s instructions. Deteriorated substrates and causes of such deterioration must be corrected before encapsulation.	\$5-10/lf or ft ²

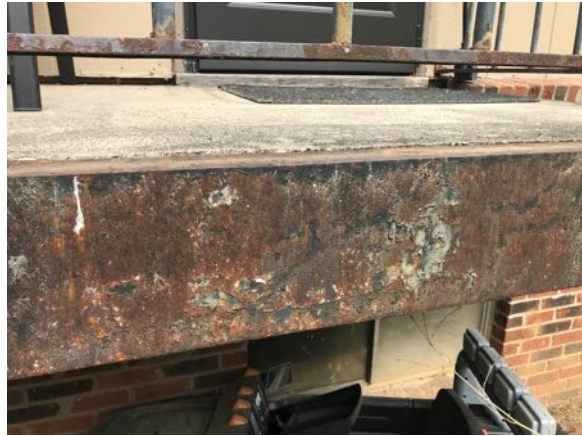
Photo 30 - Typical back porch metal floor frame - POSITIVE

Options are shown for BOTH Interim Controls and Abatement unless noted otherwise		Chosen Option
Paint film stabilization for the components listed, includes wet scraping and repainting – Deteriorated paint must be wet scraped prior to repainting or encapsulation – – NOT SUITABLE FOR ABATEMENT	\$5-10/lf or ft ²	
Component enclosure with vinyl or metal siding	\$5-10/lf or ft ²	
Lead Paint removal and repainting with lead-free paint	\$5-10/lf or ft ²	
Encapsulation – Deteriorated paint must first be stabilized before encapsulation with a lead-paint Encapsulant as per manufacturer’s instructions. Deteriorated substrates and causes of such deterioration must be corrected before encapsulation.	\$5-10/lf or ft ²
